Zing at Central House - 2020

Central House with about 2,500 sq. ft. A facility that holds group meetings 7 days per week. Due to Covid outbreak facility was closed April and May with meetings resuming in June. When the meetings started again there was a 30 person limit for 3 meeting per day. Starting in September meetings were increased to 6 per day with a 30 person limit per meeting. This calculates to 180 people per day, 7 days = 1260 people per week.

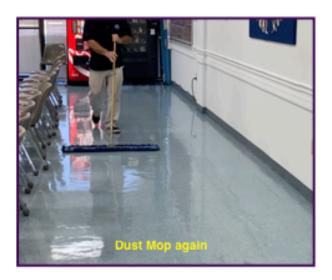
Dust mop to remove loose dust and dirt. Apply KLEEN-UP to floor and allow to sit 2-3 minutes. Clean area with high speed burnisher and Americo Blue Blend Burnisher.

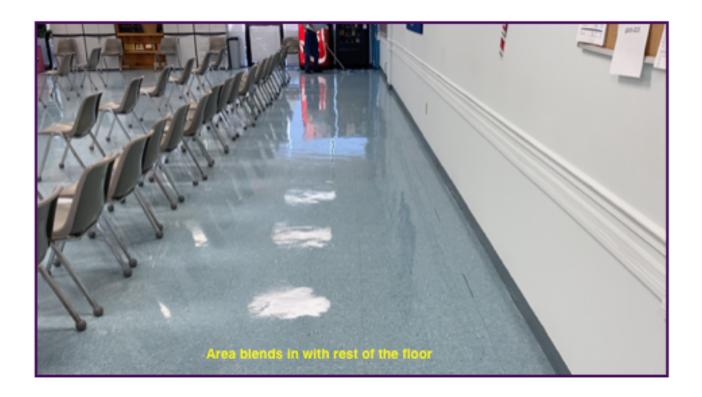
Area spray cleaned, marked with UV marker and 1 coat of **Zing First Impression Coating** applied. Now Mark will continue cleaning the floor with **Zing KLEEN-UP** diluted 1 oz. per gallon cold water in a mop bucket.
